RESEARCH MEMORANDUM

PRELIMINARY RESULTS OF NATURAL ICING OF AN AXIAL-FLOW TURBOJET ENGINE

By Loren W. Acker

WASHINGTON
August 6, 1948

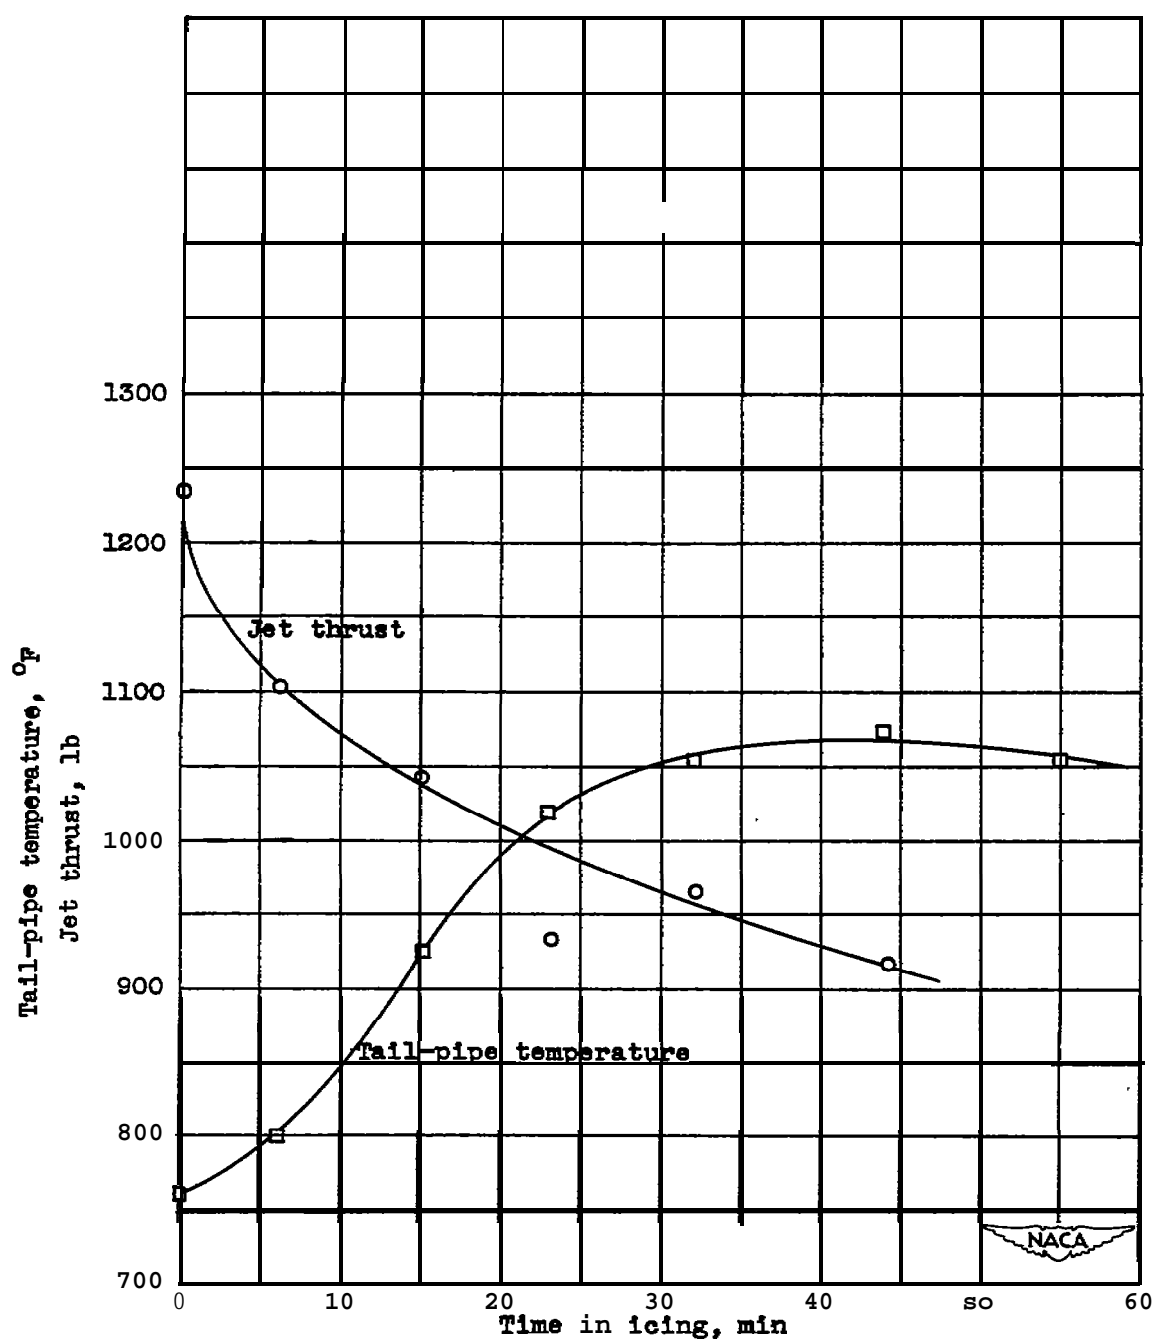
The effect of the ice formation on the engine thrust and tail-pipe temperature is shown in figure 4 as a function of time in the icing condition. The engine was operated at a speed of 9000rpm in an icing condition for approximately 1 hour. Engine data were taken before the icing cloud was entered and periodically during the encounter with the icing condition. At the end of 45 minutes, the engine thrust had decreased from 1234 to 910 pounds, a reduction of approximately 26 percent. After 45 minutes, the tail-pipe temperature had reached its maximum rise from 761° to 1065° F. At this point during the encounter, the tail-pipe temperature appeared to stabilize. The greatest decrease in thrust and increase in tail-pipe temperature appeared to occur in the first 15 minutes of the encounter.

Figure 4. - Effect of time in icing condition on engine jet thrust and tail-pipe temperature at engine speed of 9000 rpm.
